Wind turbine operations in northern Siberia

Wind Turbine Operation in Tiksi

Russian Far East Energy Infrastructure Demonstration Project as NEDO project of Japan

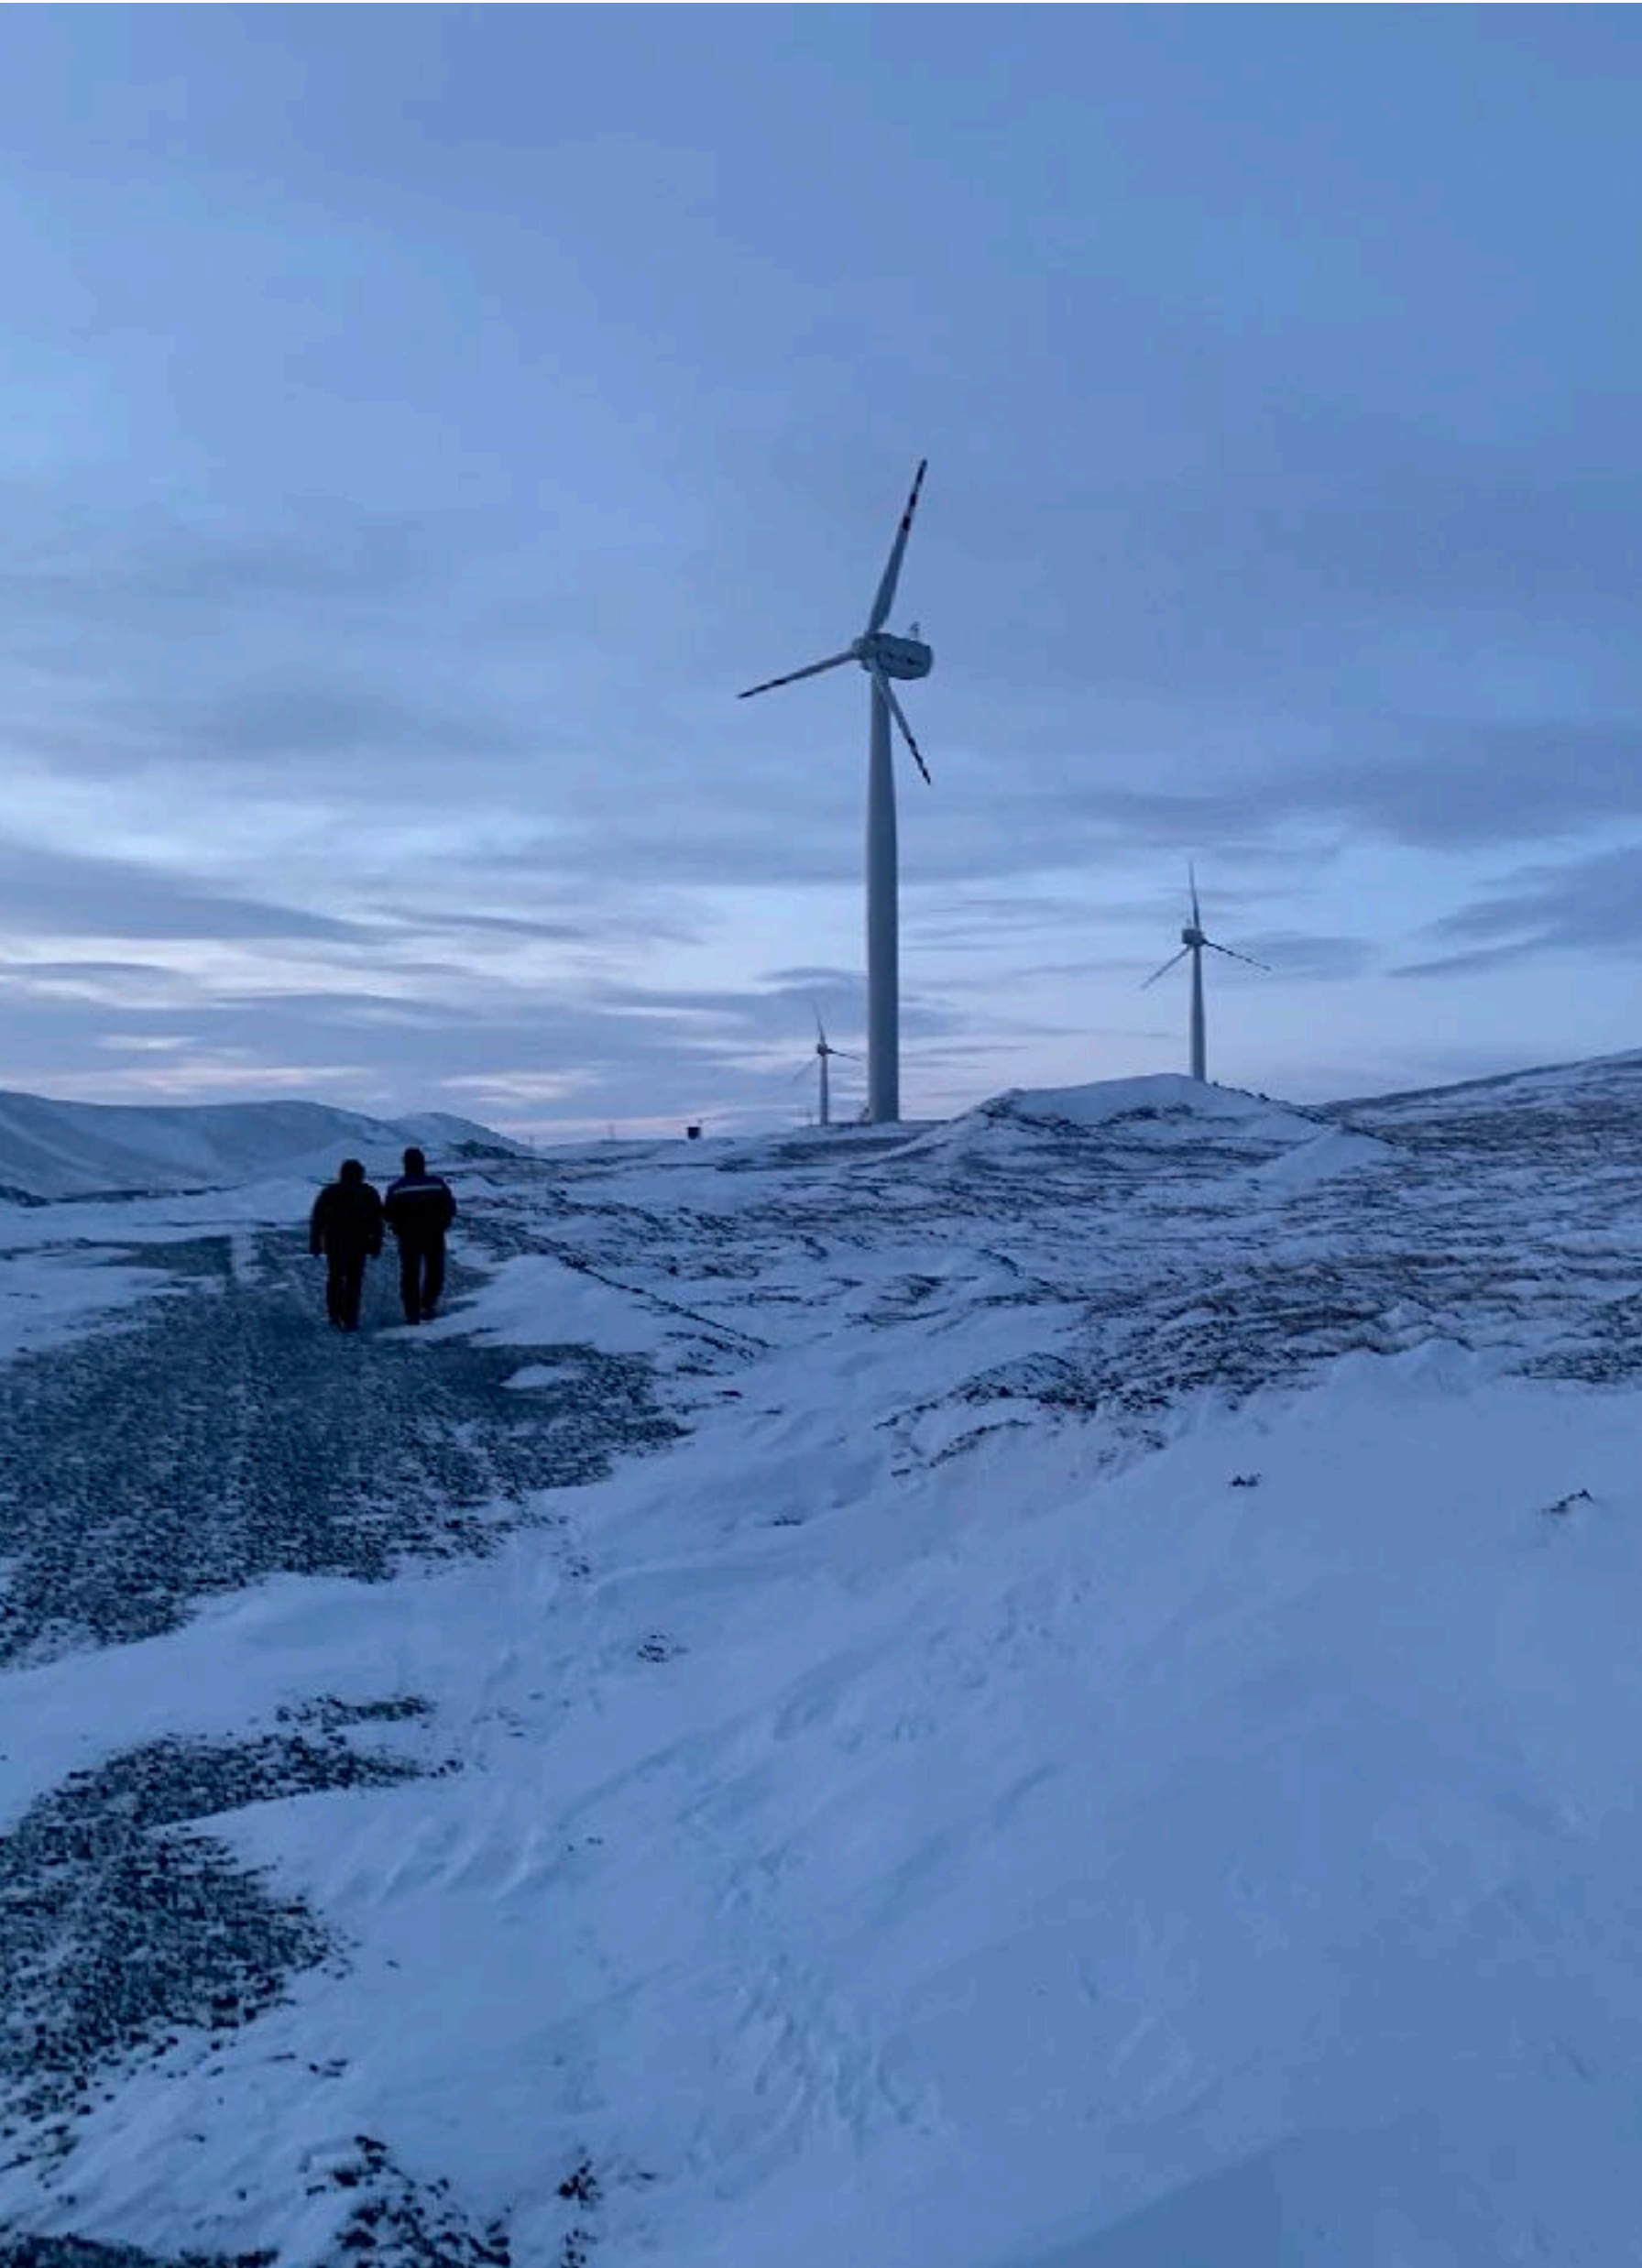
Specification of Wind Turbine: KW300

Wind turbine type	3-blades upwind type
Rated power	300 kW
Cut-in wind velocity	3 m/s
Cut-out wind velocity	25 m/s
Hub height	41.5 m
Blade length	16.5 m
Blade feature	Hard to get ice Easy to peel off ice
Nacelle feature	Have any sensors for detection icing Add Fan-heaters to protect some devices against low temperature
Tower feature	Keep tenacity at low temperature
temperature range	-35 ~ +30 °C (Operate) -50 ~ +40 °C (Standby)

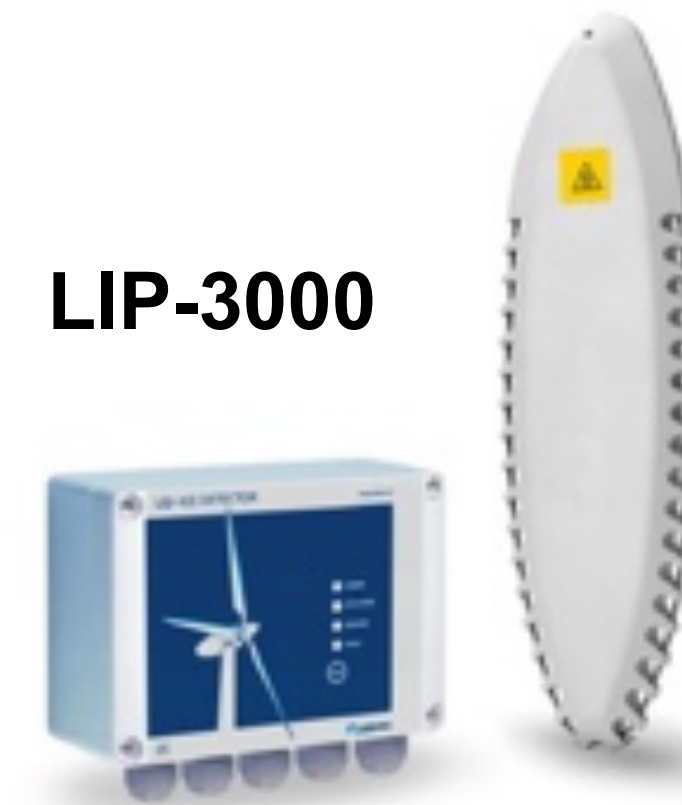
■ Step 1 : Identify the blade icing time

- Apply T19 Ice Loss Method (old version)
- Compare with Ice detector (LIP-3000)

■ Step 2 : Find possible source of water droplets

- Combine the result of Ice Loss Method and operating data on site
- Determine wind turbine status just before the icing event

■ Step 3 : Verify the source from public data

- Observed sea ice by satellite images provided by National Snow and Ice Data Center (NSIDC)

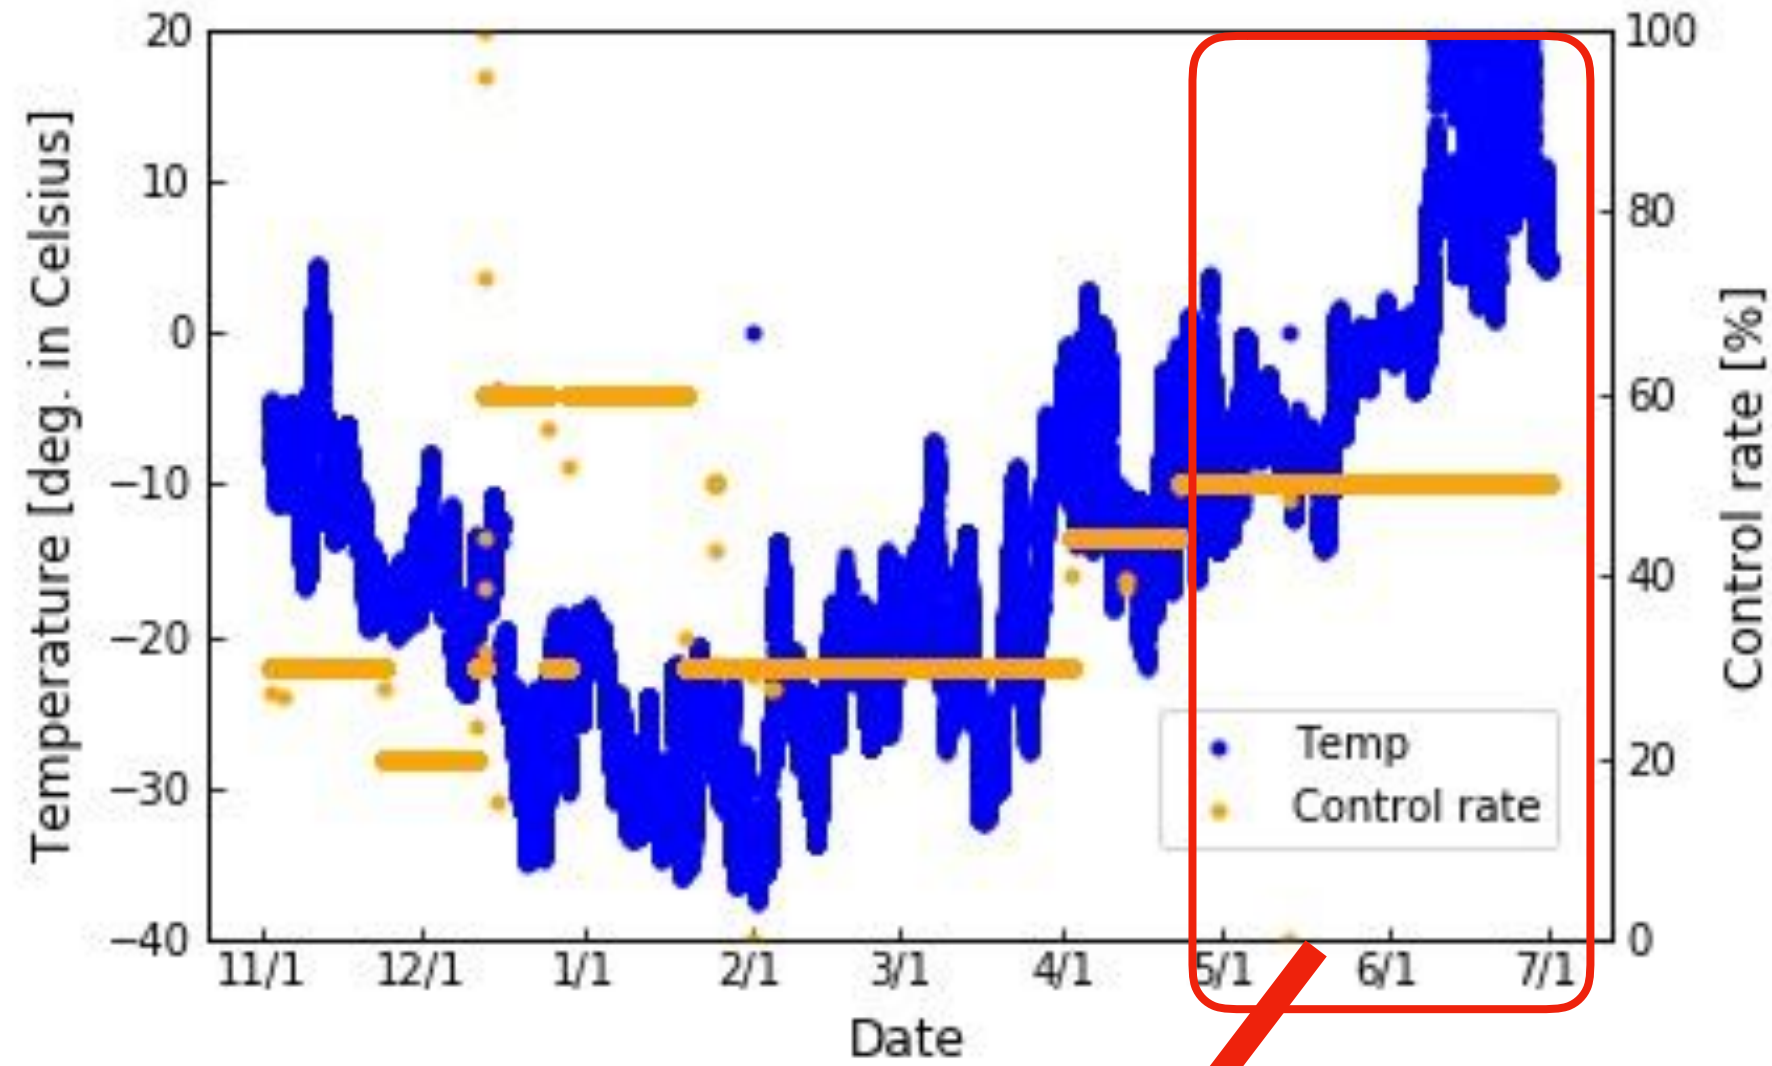
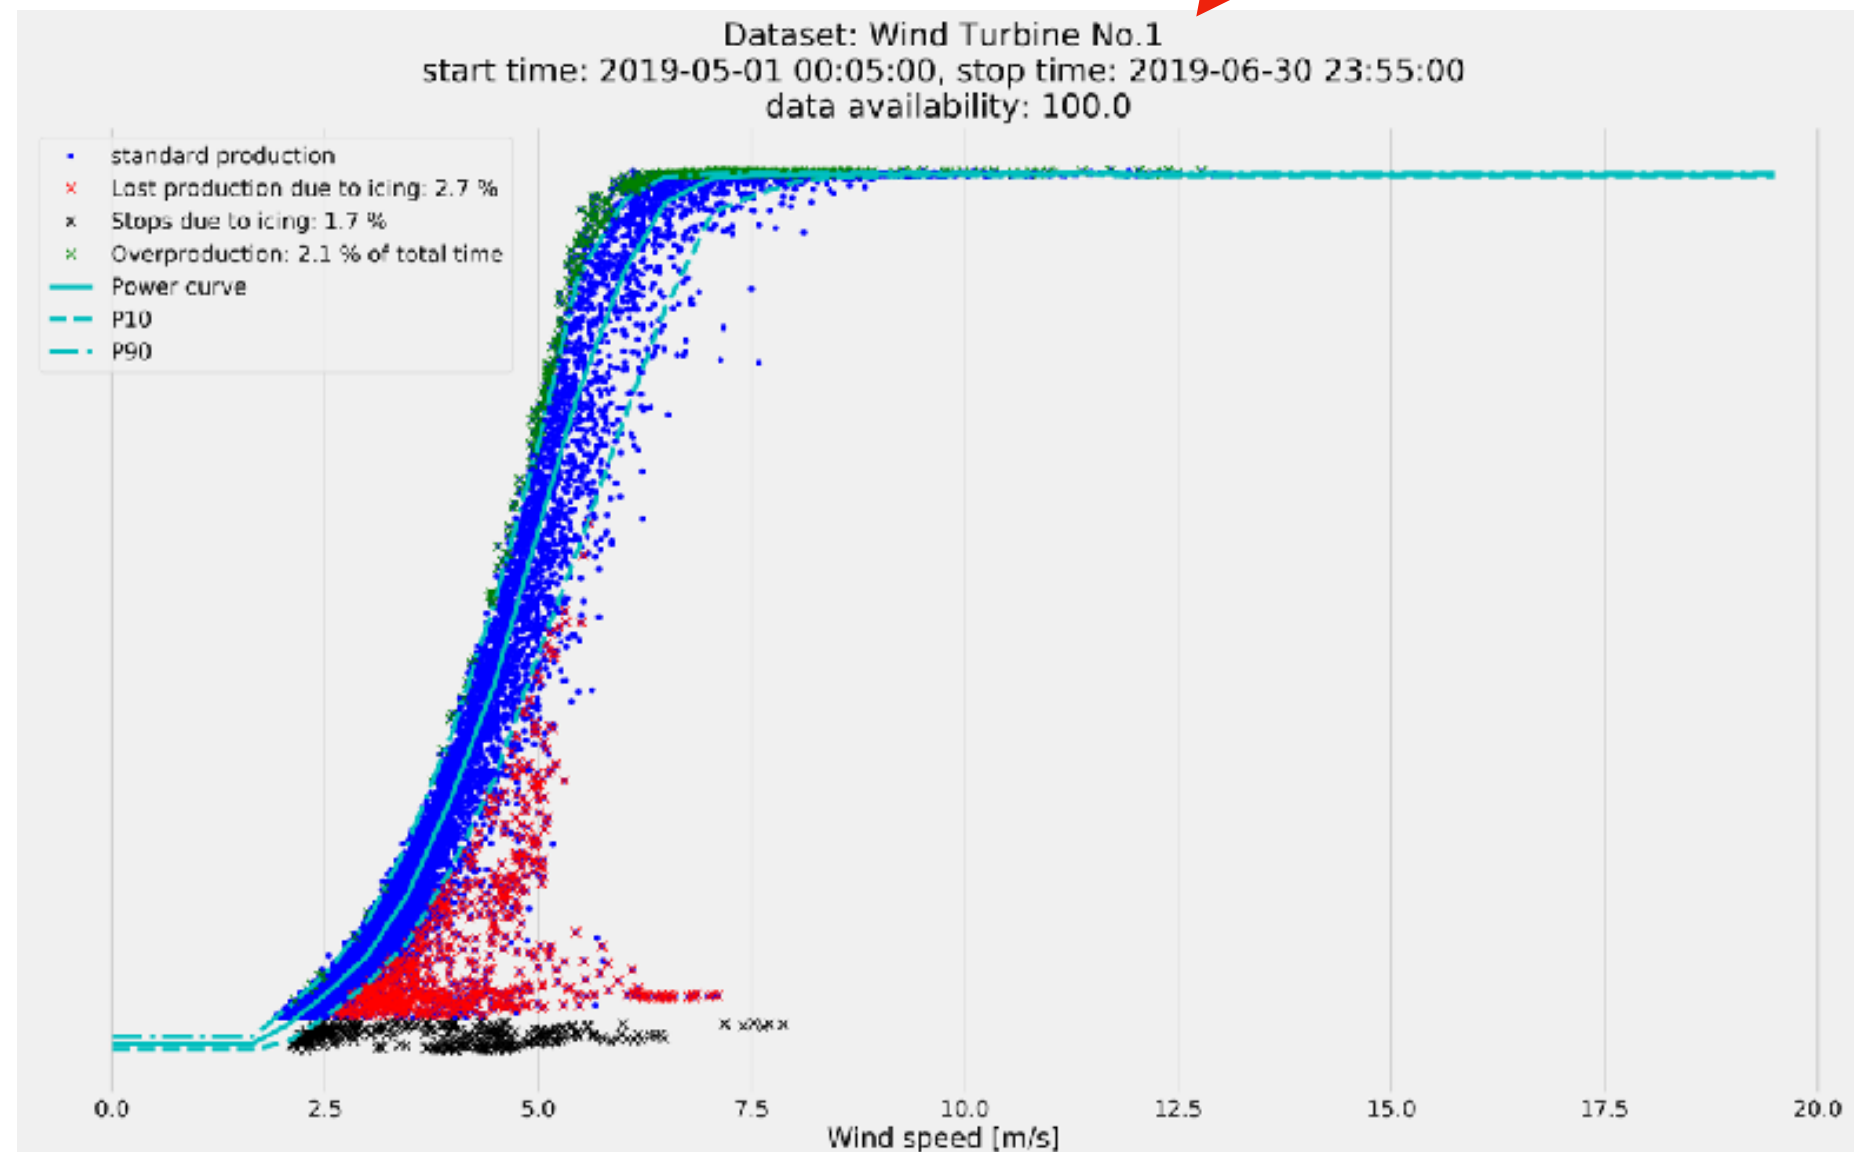
Output Control

- Applied Ice Loss Method for SCADA data between 5/1 and 6/30 when the rated power was set to 150 kW
- Colored background in the fig. shows the production loss or stops due to icing
- Most icing time calculated by Ice Loss Method correspond to the measurement of ice detector.
- Icing was observed frequently from 5/20 to 6/3 when ambient temperature was slightly below 0 °C

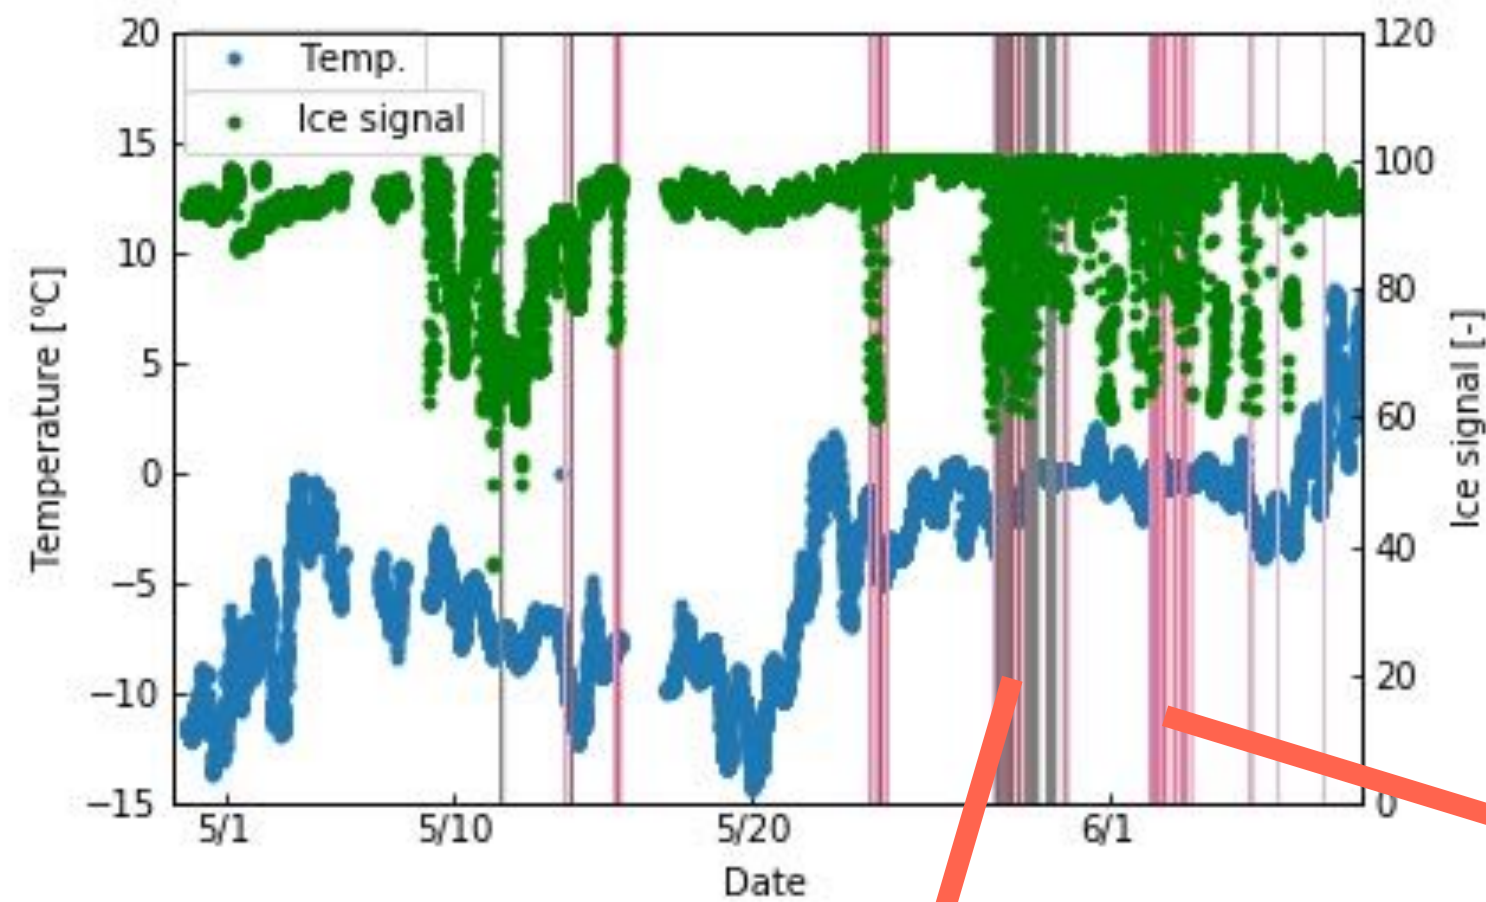
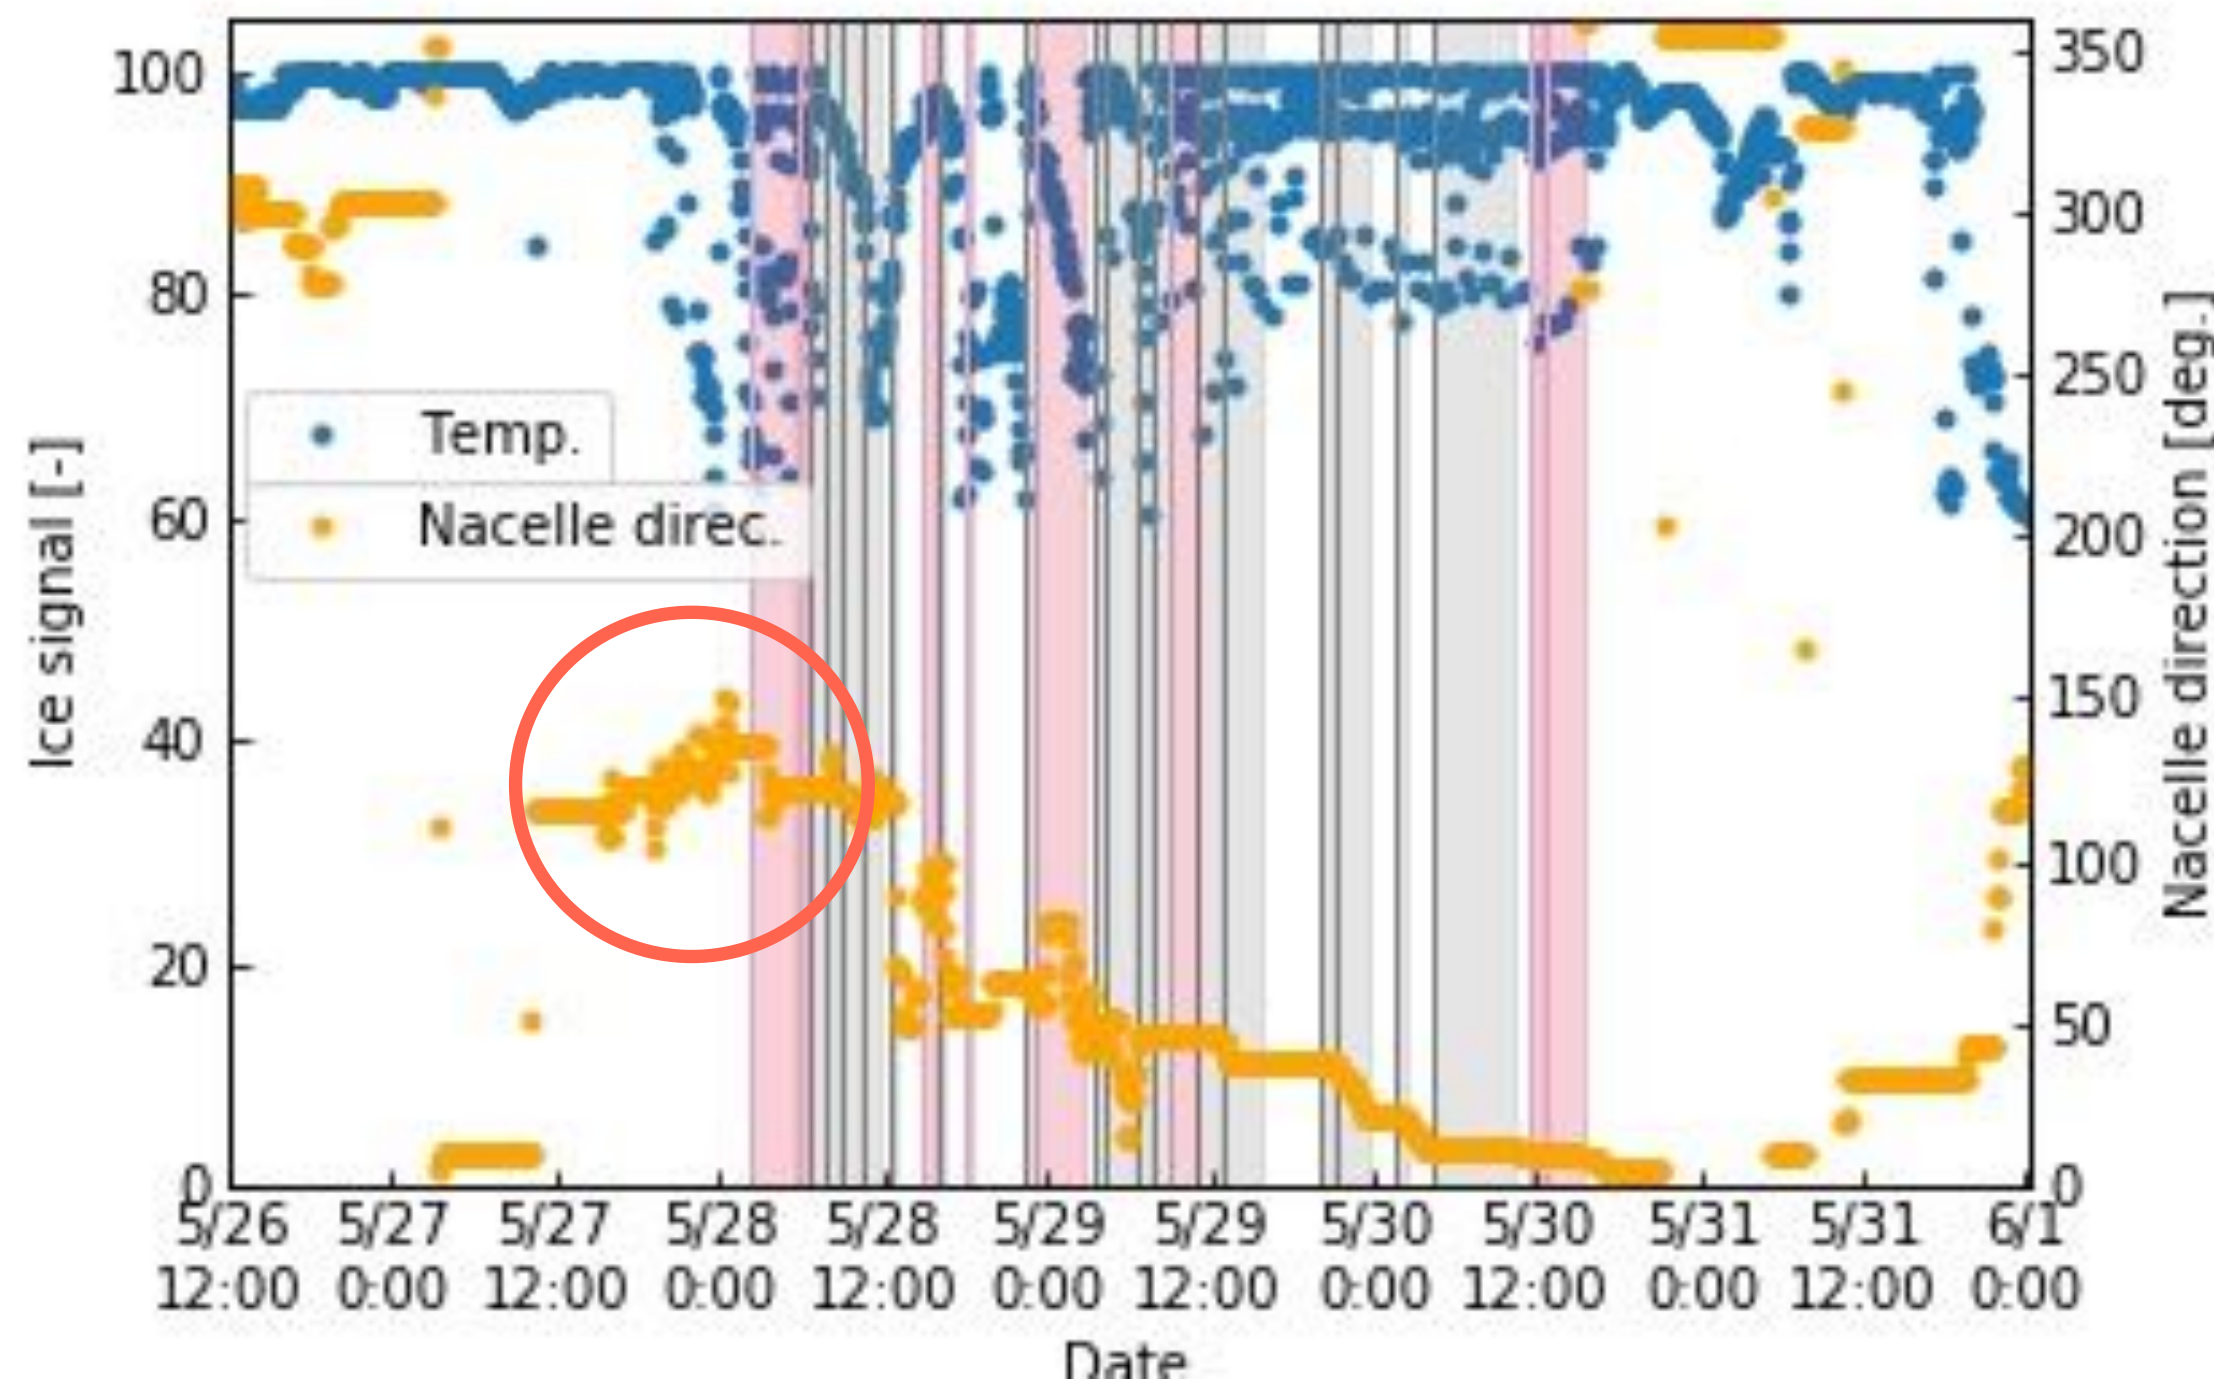
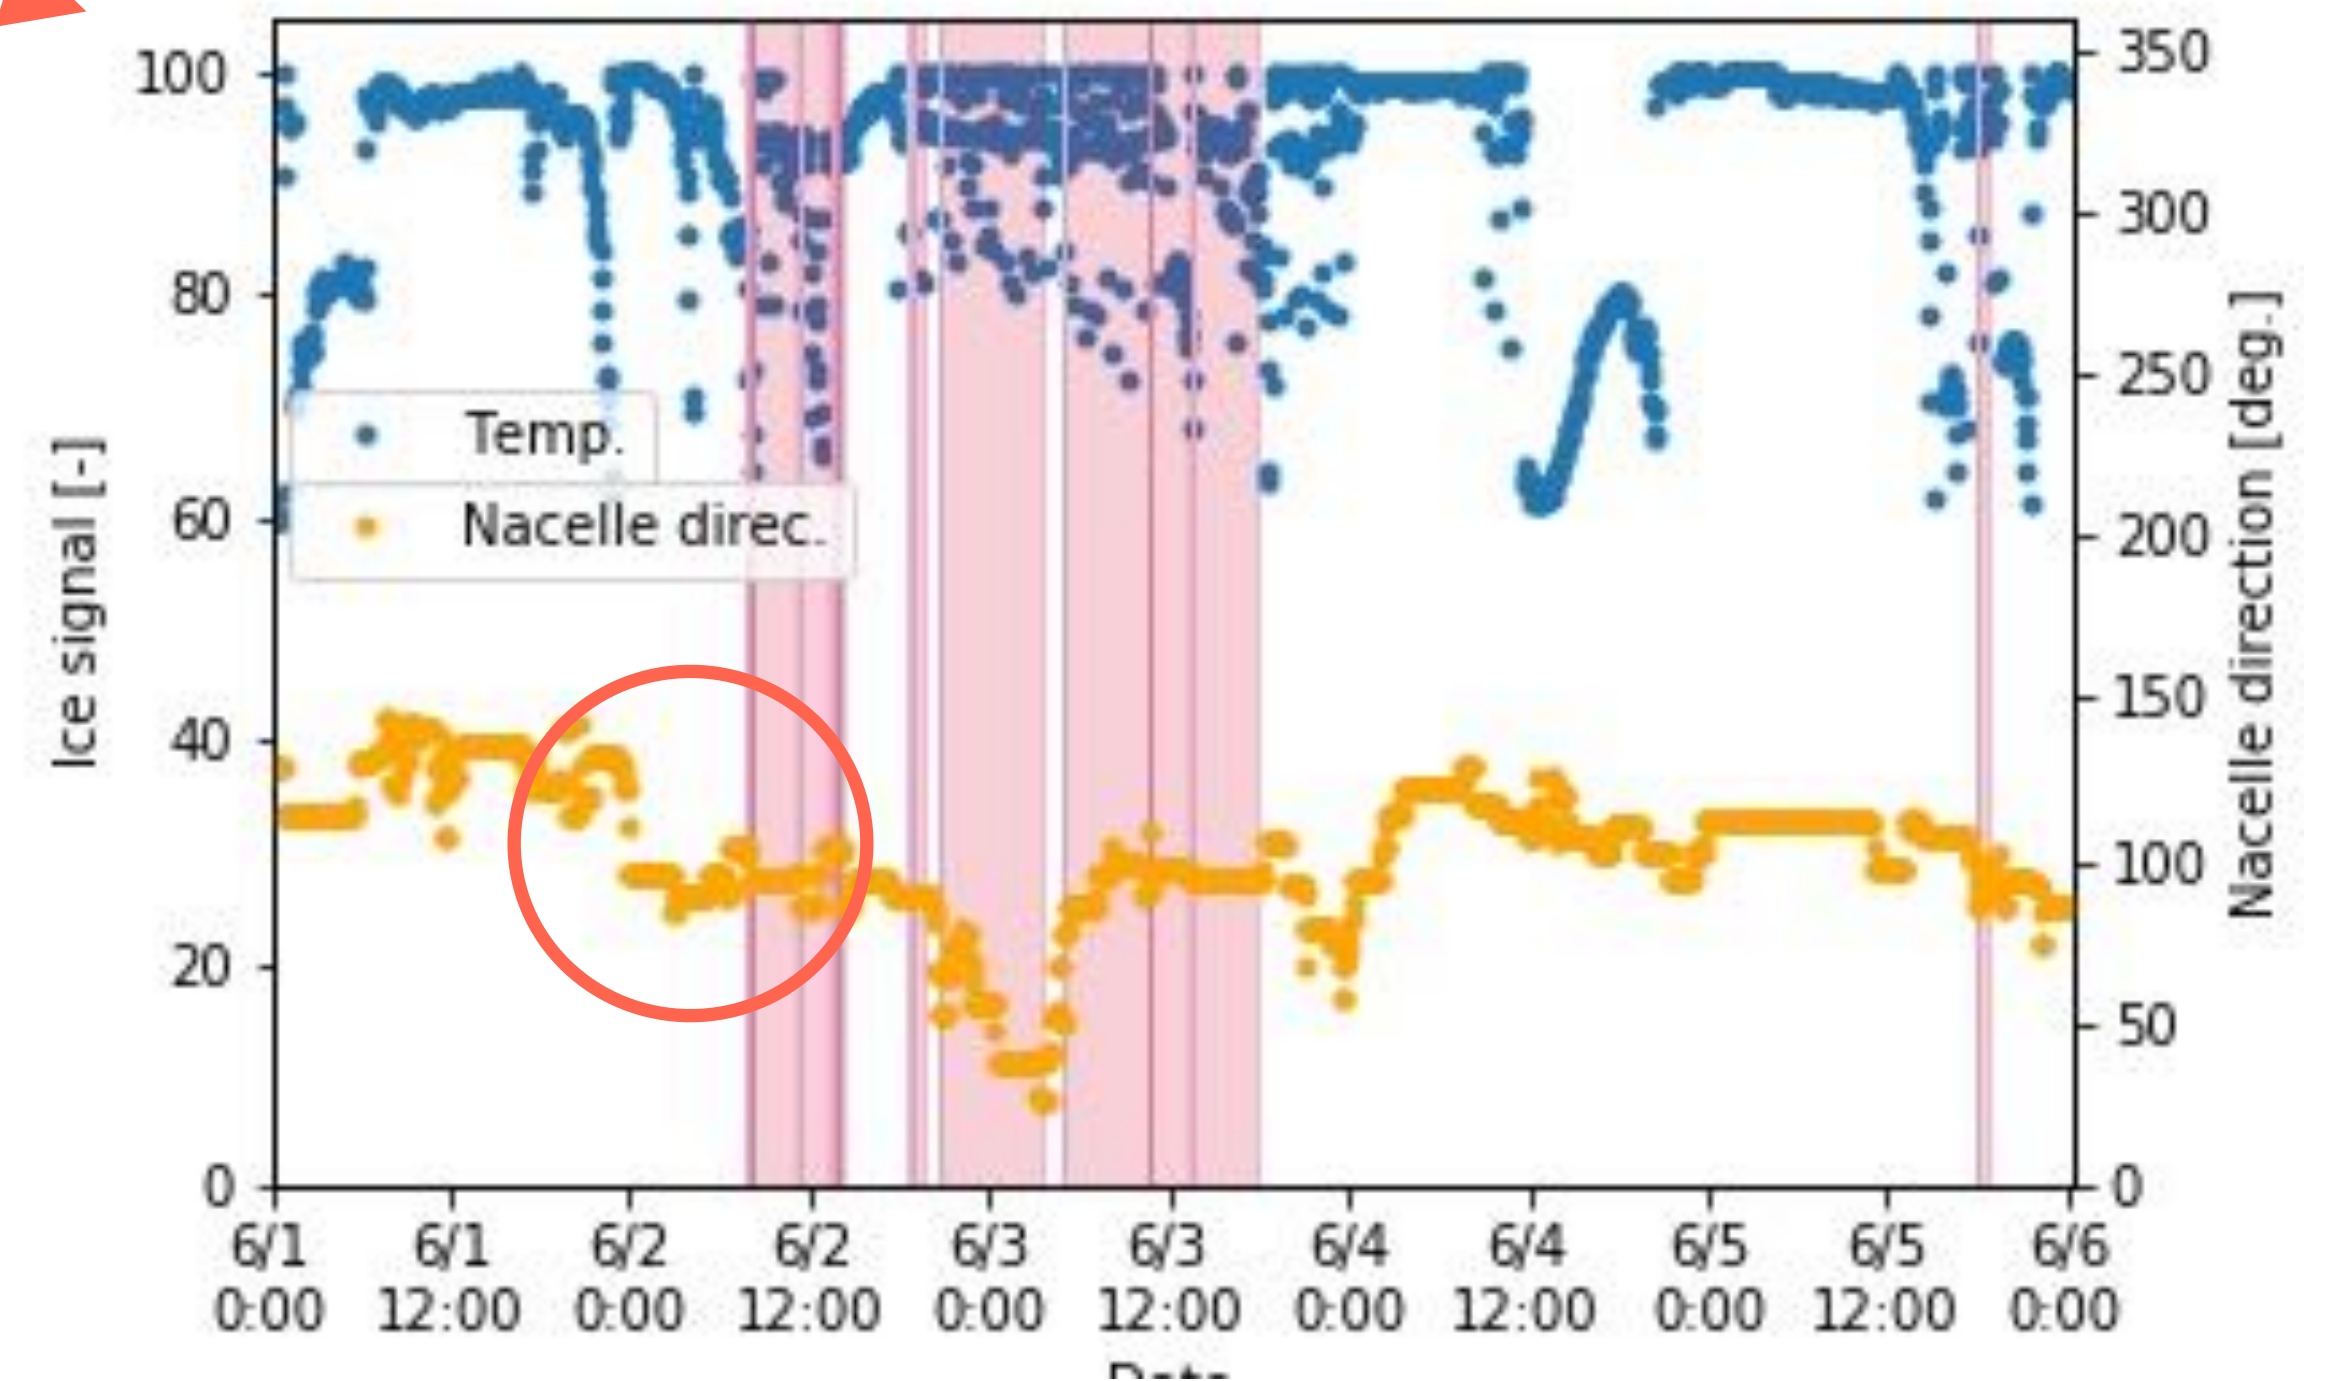
- Details of 2 icing events are shown below
- before production loss occurred, the turbine was in production facing toward between **90** and **135** deg.
- turned out that icing occurred when the turbine operated facing to the nearest sea
