# BLADE DEFECT FORECASTING

# Blade Defect Forecasting for the Wind Industry

Grand Solution project

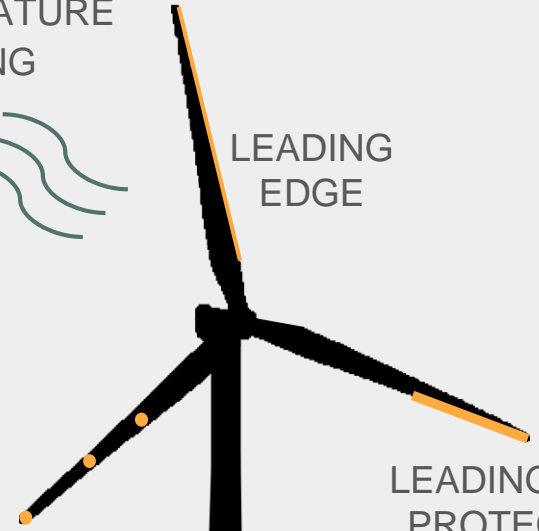
## ENVIRONMENTAL PARAMETRES

TEMPERATURE  
LIGHTNING  
RAIN  
WIND  
UV

LEADING  
EDGE

LEADING EDGE  
PROTECTION  
LEP

LIGHTNING  
PROTECTION  
LPS

LOCATION

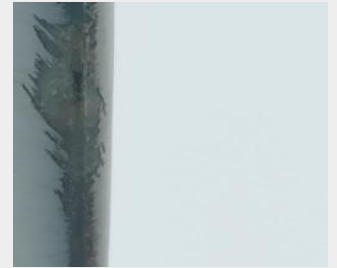
Wind turbine blades are designed for +25 years, but erode much faster than expected

EROSION  
PAINT

EROSION  
FILLER

EROSION  
SURFACE MAT

EROSION  
LAMINATE

EROSION  
CORE

SEVERITY

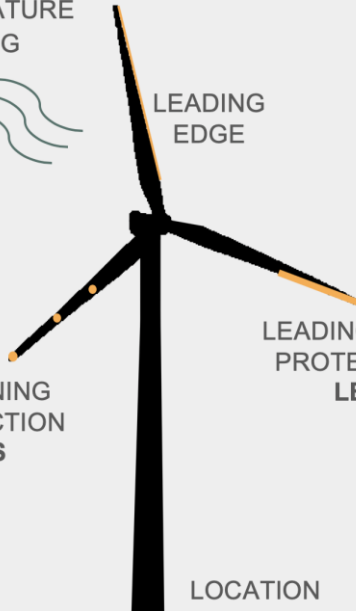
### ENVIRONMENTAL PARAMETRES

- TEMPERATURE
- LIGHTNING
- RAIN
- WIND
- UV

LEADING EDGE

LIGHTNING PROTECTION LPS

LEADING EDGE PROTECTION LEP

LOCATION
